# 2014 Report

## Glenturk River Rehabilitation

Bangor Angling Club  
Bangor Erris, Ballina, County Mayo  
11/21/2014

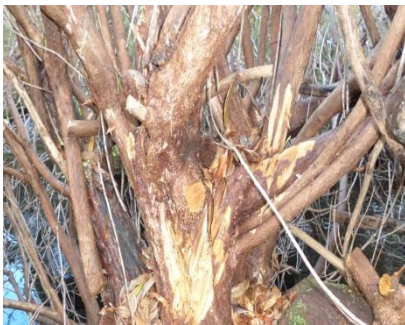
*Picture No.01 above identifies notching & scaring to the tree trunk by means of chainsaw pre chemical application*

Option No.5 (notching and chemical treatment) proved to be the most successful and practical with regards to time taken and quantity of chemical being used.

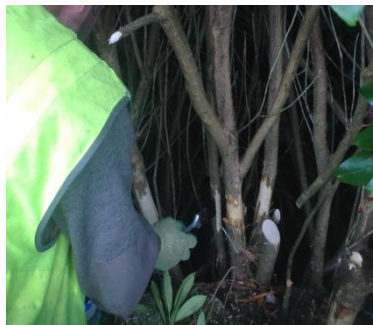
*Picture No.2 above identifies stripping of the bark from the tree trunk pre application of chemical*

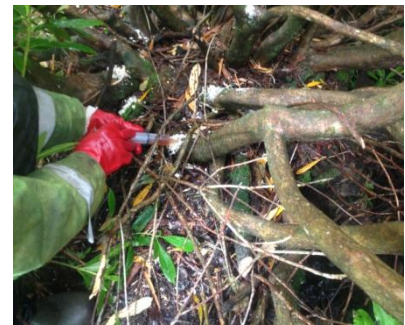
*Picture No. 3 above identifies the boring and chemical injection of the tree trunk.*

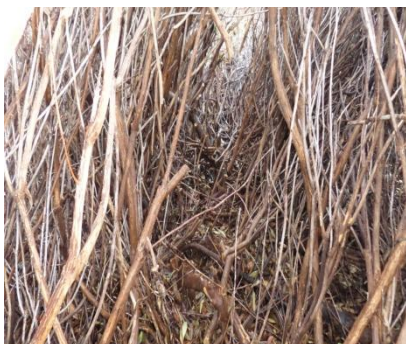
*Picture No.04 above identifies density of the rhododendrons' and narrow access tunnels*

One of the utmost challenges was to gain access through the dense bushes of invasive species as to be able to treat them correctly. The contractor's operatives had to cut their way in through narrow tunnels in order gain access to the centre of the bushes to conduct their work. A chainsaw was then used to cut notches and scars into the trunks and stems of the bushes with the chemical roundup being applied directly afterwards. The instant direct application of the chemical is of highest importance as to prevent the natural resin in the wood forming a seal to its surface and block out the chemical from being absorbed into its root system.

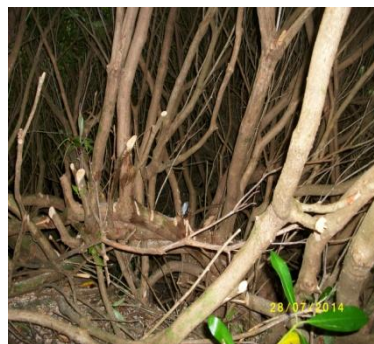
*Picture No.5 above identifies application of chemical to notches.*

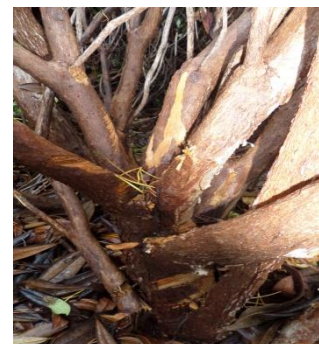
*Picture No. 6 above identifies Notching and scarring of trunks prior to chemical application.*

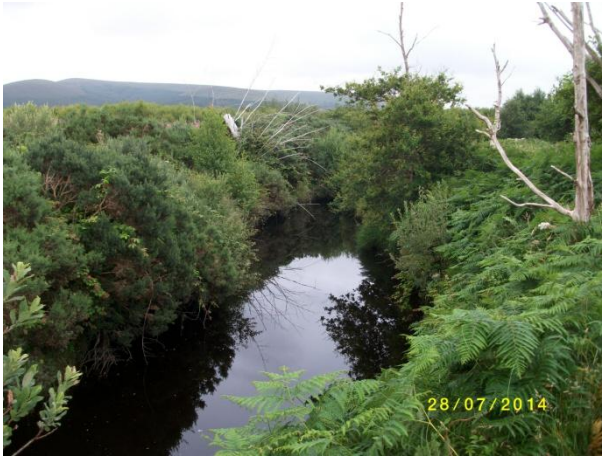
Overshading of the river by invasive species.

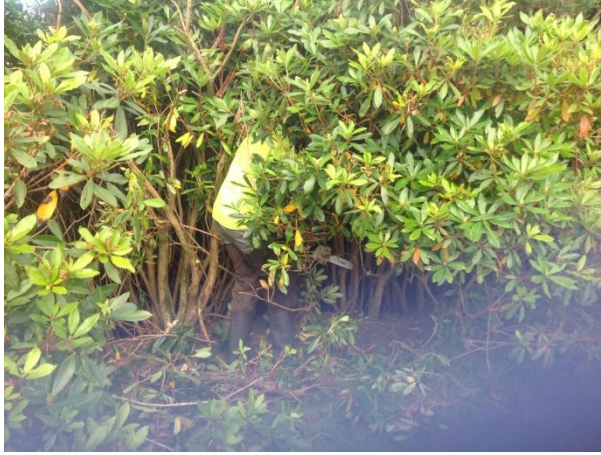
Operatives working through dense rhododendrons notching them with a chainsaw and applying chemical.

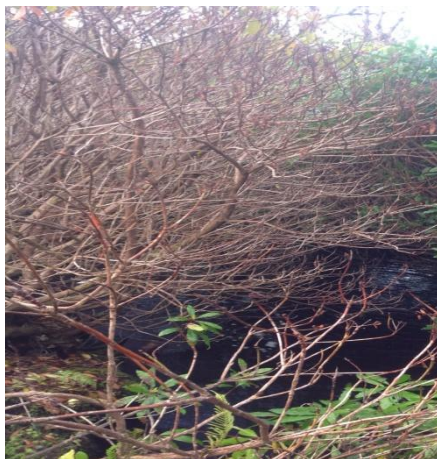
4 weeks post treatment clear evidence of dieback.

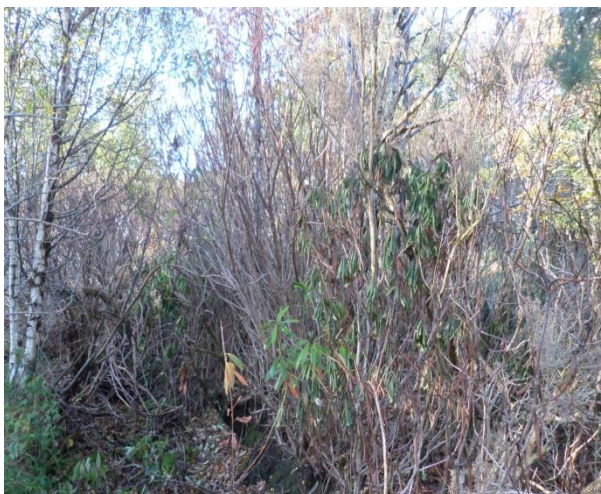
4 weeks post treatment clear evidence of dieback.
